RETROFITTING OF A MASONRY ARCH VIADUCT AND CULVERT

J. Hołowaty¹, D. Jurkowski², G. Zimny²

SUMMARY

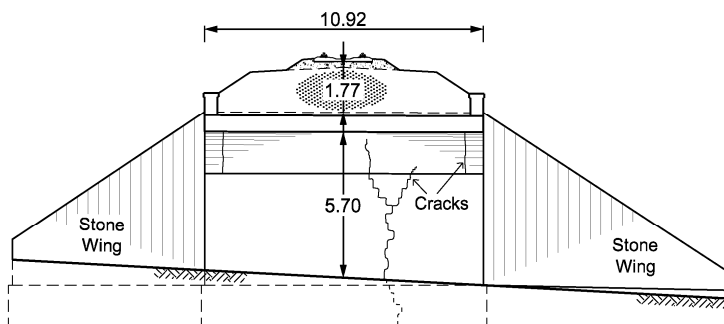
Fig. 2. Viaduct cross section.

There were characteristic fine cracks in the viaduct barrel beneath the spandrels, which were wider at the crown. The width of the cracks at the crown was 2-3 mm beneath the north spandrel and 1-2 mm beneath the south spandrel (Fig. 2). There was also leakage on the external parts of the brick barrel. In the middle section of the barrel arch there were small cracks issuing from the wider cracks in the supports and foundations. However, the general condition of the viaduct was surprisingly good, given its long life. Cracks in the edge sections of railway barrel arches can very often be found due to transversal deflection of the spandrels [1, 4-6]. The cracks in the middle section of the barrel arch were evidence of uneven settlement on stiff clay and clayed sand substrata. At the crack location a humid plastic clay was found in the strata. The crevices in the stone walls of the supports were along the vertical and horizontal mortar joints. The crevices in the wall joints led to crushed stone foundations and were wider at the bottom.

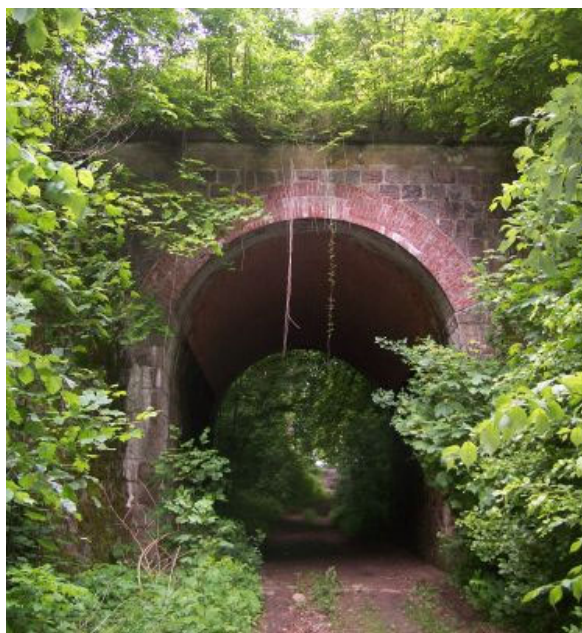
Fig. 4. Viaduct covered by foliage.

Standard rail sections S49 on concrete sleepers embedded in ballast were used in the track structure. The railway embankment slopes were poorly maintained and were covered by uncontrolled self-sown plants (Fig. 4). A section of the railway line had been closed to traffic due to the poor condition of the two truss bridges and the track structure.

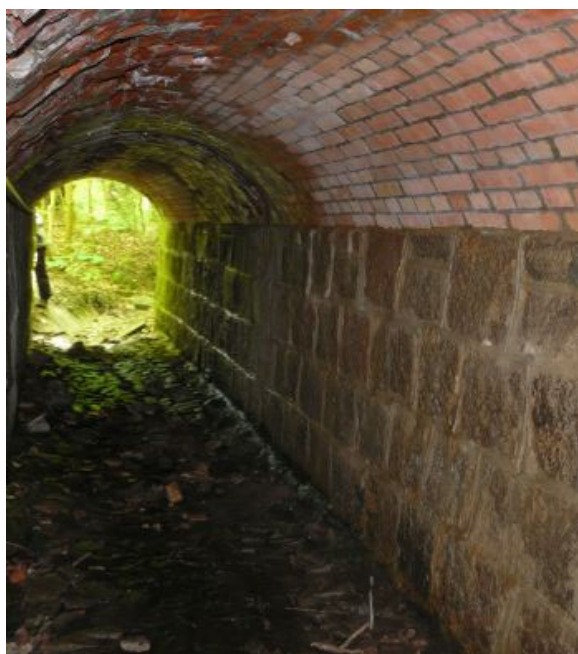
Fig. 5. Masonry culvert.

The brick barrel arches are supported by wedge-shaped stones on stone walls at the springing. The support and wing walls are stone masonry from rectangular stone blocks and mortar joints. The sections of the structure are presented in Figs. 1 to 3, with the characteristic patterns of cracks and crevices generally visible. General views of the viaduct and the culvert (conduit) before retrofitting are shown in Figs. 4 and 5, with excessive vegetation flourishing near the structure.

Damage to the culvert structure were more severe, with wider crevices in the stone wall at the settlement, and crevices and cracks in the culvert barrel arch. At the location of water shedding from the viaduct side, there was excessive leakage and dampening of the masonry walls and the barrel arch, which had resulted in the destruction of the mortar joint and brick material. The stone wall was stained by calcareous leakage. Damage to the brick parts had also appeared on the head parts of the culvert made by the water shedding on the embankment slopes. Excessive damage occurred on the end section of the culvert conduit of 5.5 m in length where water was shedding extensively from the viaduct. Crevices in the side stone walls of the culvert also in evidence through the mortar joints. The stone surfacing of the culvert bottom was found to be in very good condition.

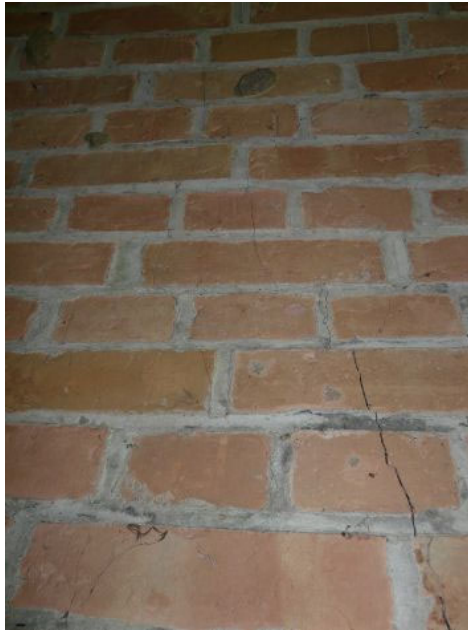
Fig. 7. Detail of a crack in barrel arch.

General views of the viaduct and the culvert during the finishing works are shown in Fig. 6. Figures 7 and 8 present the longitudinal cracks in the viaduct brick barrel before and after repair. The brick masonry is very sound despite the cracking.

To prevent a repeat of the cracking and leakage of the brick barrels beneath the spandrels, their connections were strengthened at the crowns with reinforced concrete strips. The crevices in the stone footings were also secured with small reinforced concrete walls (patches) with anchors. For construction of the strengthening reinforced concrete members, self-compacting concrete was used. The cracked joints of the stone walls in the supports were strengthened by the installation of flat steel bars into the new joint mortar. It was estimated that such means of strengthening would be sufficient to prevent further development of cracking, in addition to not giving too much rigidity to the brittle masonry members susceptible to cracking and splitting.

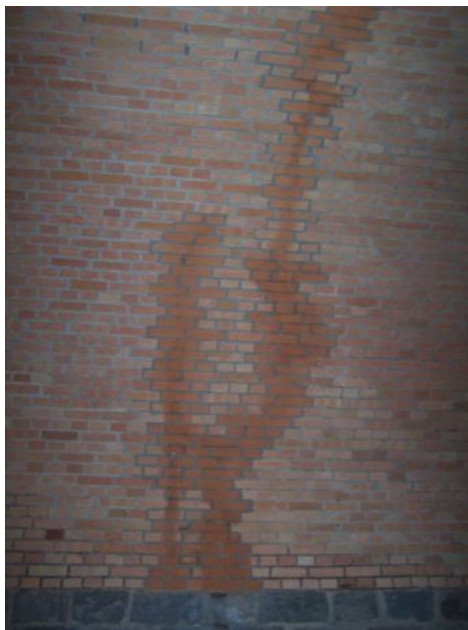
Fig. 8. Cracks after repair.

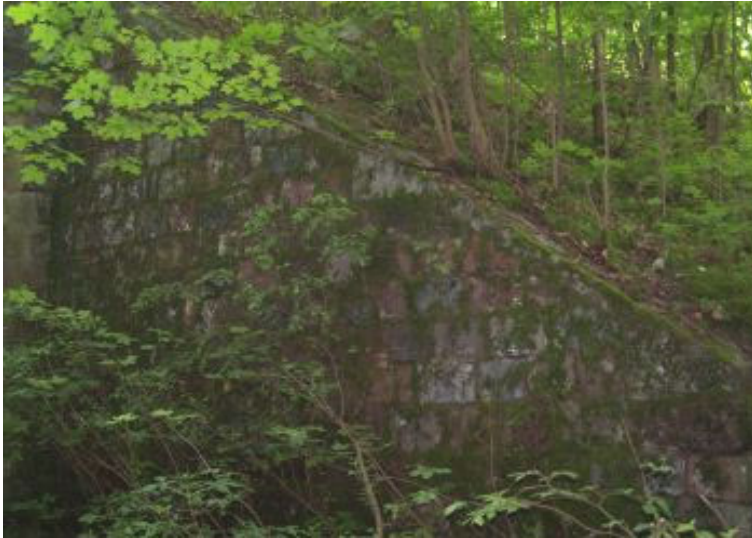
Fig. 9. Stone wing before cleaning and repair.

Fig. 9 and Fig. 10 show the technical condition of the stone wing before and after cleaning and repair. In the masonry wings vegetation had been allowed to thrive, which had resulted in some uncertainty about their soundness. After cleaning and repointing they appeared to be very sound.

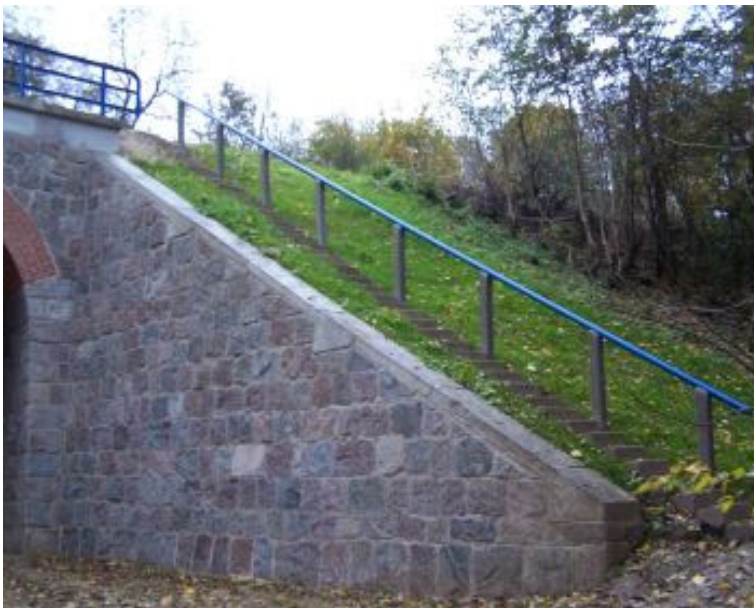
Fig. 10. Stone wing after cleaning and repair.
