RESTORATION WORKS CARRIED OUT AT HISTORICAL MALABADI BRIDGE

H. Sert, S. Yılmaz, H. Demirci, A. Avşın, M. Nas, G.S. Turan, N. Apaydın
H.İ. Korkmaz

Ministry of Transport, Maritime Affairs and Communication, General Directorate of Highways, Department of Structures, Division of Historical Bridges, Ankara, TURKEY.

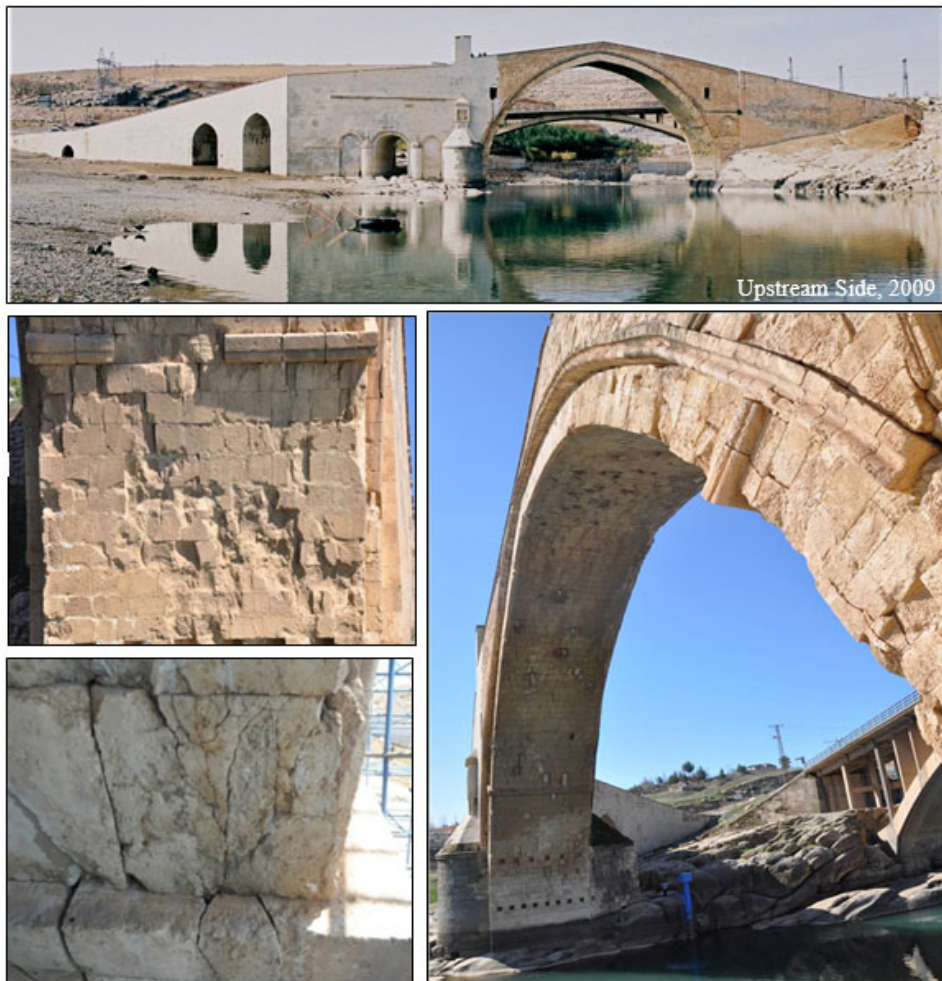
Malabadi Bridge which provides a passageway for the road on which it is located for centuries has survived to date without any substantial structural damage. However, during repair works carried in 1954 and 1985, the surfaces were plastered by cement base mortar other than the surfaces on the intrados and spandrels of the main arch while the bridge was paved with concrete. In order to prevent the gradually increasing disfiguration of the stones due to the effects of the variable water flow from the nearby dam and clear the traces of the repairs made most lately and which have been deemed not to be in harmony with the original pattern of the bridge, the bridge was included in the program in 2009 [6], (Fig. 2).

Fig. 2. Pre-restoration view of the bridge.

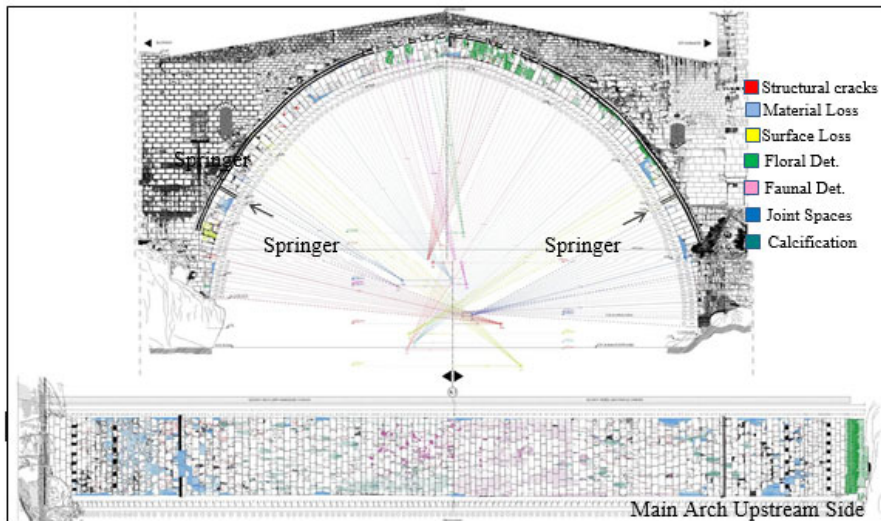
During surveys executed on June 2009, the bridge surfaces were scanned in 3D through ground laser scanning method and the bridge and its vicinity were documented with the survey drawings and photographs. Apart from such studies, the structural problems were determined the deteriorations observed on the stone were classified. Accordingly, there observed losses on the surfaces of the original stones in exfoliated form excluding the surfaces plastered during late period repairs, abrasions in coarse porosity form and detachments which may be in the form of various pieces at different dimensions and may get deeper occasionally. In addition, there observed structural and superficial cracks at springer level of the main arch within intrados while it is considered that such cracks are due to the crushed masonry materials and the capillary cracks on the stone. All such visual observations are shown on the visual decay analysis in colored form with legends under the titles of superficial/structural cracks, material and surface losses, floral and faunal deteriorations, joint spaces etc [6], (Fig. 3).

Fig. 3. Visual decay form of K1 (Main) arch of the bridge.

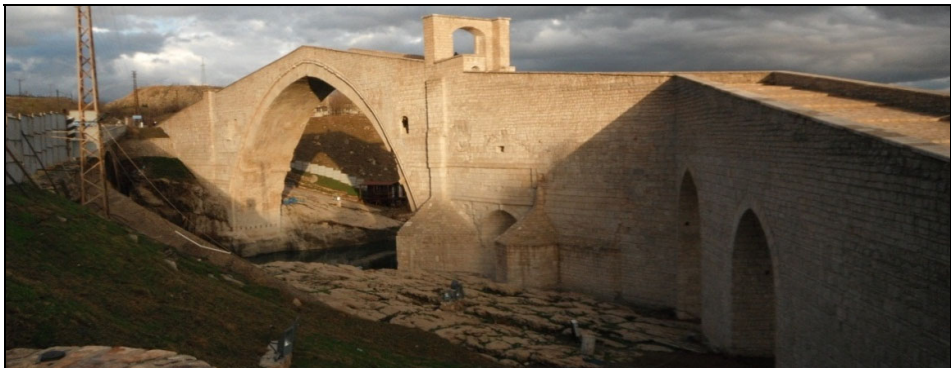
Fig. 4. Post-Restoration view of the bridge.
