Arch bridges in East Blacksea Region of Turkey and effects of infill materials on a sample bridge

A. Ural and A. Doğangün

Karadeniz Technical University, Department of Civil Engineering, Trabzon, Turkey

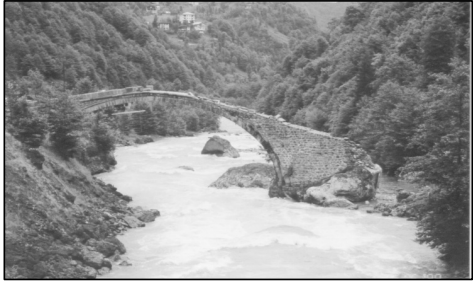
a) Orenkit Bridge

Figure 1 : Some deteriorations and failures of the bridges located in Trabzon.

Some of damaged stone arch bridges taken from the East Blacksea Region are illustrated from Figure 1. The Orenkit Bridge located between Ardeşen and Çamlıhemşin districts, was being exposed a heavy flood and the evacuation arch of it was destroyed (Figure 1a). After destruction, the evacuation arch was built again and some other parts of the bridge were repaired. Nowadays it is in perfect condition, because of the restoration. According to Figure 1b, because of vegetation and biological colonization, Yavşan Bridge on the road of Dereli district, needs conservation and rehabilitation. Because the plant groups which settle down in the structure of the bridges have taken their roots into the body of bridges and caused severe damage. Cleaning and removal of infesting vegetation, the execution of the waterproofing and drainage are necessary to prevent these damages. Another kind of deterioration is illustrated from Figure 1c. Probably due to time dependent factors or weak durability of masonry materials, Bekçiler Bridge at the historical Silkway on Zigana mountain pass, being exposed this damage. From Figure 1d, another damaged stone arch bridge (Kalkanlı Bridge, between Trabzon-Torul) is illustrated. Although most parts of the bridge were collapsed, the arch form of it was remained. It
