REPAIR AND STRENGTHENING OF ARCH BRIDGES IN THE FRAME OF MODERNISATION OF SLOVAK RAILWAY NET

Peter Koteš*, Miroslav Brodňan* & Vladimír Piták⁺

3.1 Reconstruction of object SO 12.33.06

3.2 Reconstruction of object SO 12.33.05

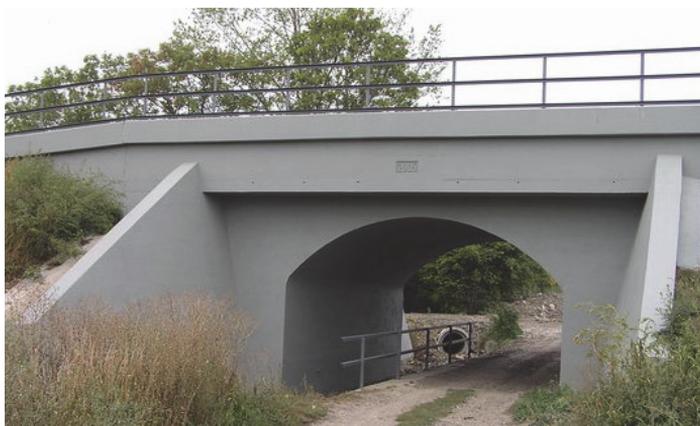
Figure 3: View on arch bridge after reconstruction

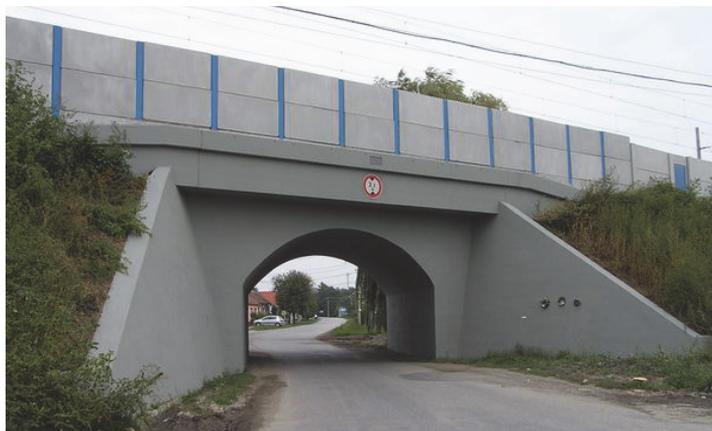
Figure 6: View on arch bridge after reconstruction
