## CONDITION ASSESSMENT OF STEEL ARCH BRIDGES BASED ON AMBIENT VIBRATION TESTING

## 2. BORÇKA STEEL ARCH BRIDGE

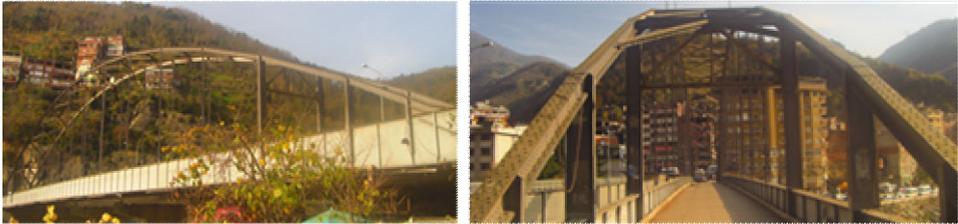
The investigated bridge is located in the Borçka district of Artvin Province, Turkey, and it has steel arch structural system. The bridge, built in 1936, is on the Çoruh River in the town center of Borçka. Total length and width of the bridge are about 114m and 5.30m, respectively. The main structural system of the bridge has 16.30m arch height from the bridge deck. The bridge abutments are made of stone masonry walls. The structural elements (arches, pillars, decks, wind connections etc.) are made of steel with riveted connections. Bridge is closed to vehicle traffic, it is open only to pedestrian traffic. Some views from Borçka Steel Arch Bridge are given in Fig. 1.

*Fig. 1. Views from Borçka Bridge.*

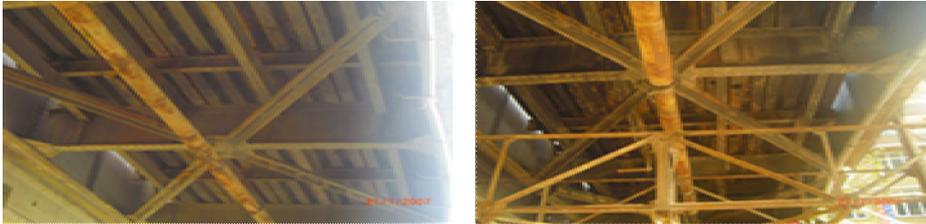
*Fig. 2. Longitudinal and transverse cross members.*

It can be generally stated that there are important corrosion problems, especially under the deck elements, in the bridge (Fig. 2). Besides, serious support problems are observed during the investigations (Fig. 3). However, loose and tearing was not observed in the riveted joints (Fig. 4).

- The supports of the bridge need repairing or replacement.
- The connection losses on the struts and cross-sections need repairing or replacement.
- The repair or replacement is required in the high crosses.
- The repair or replacement of the deck is required.
- All elements need cleaning and painting with protective materials.

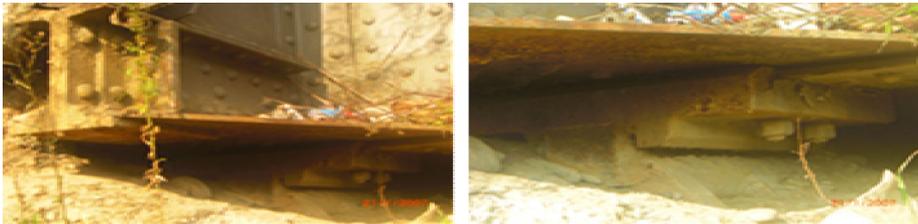
*Fig. 3. The supports of the bridge.*

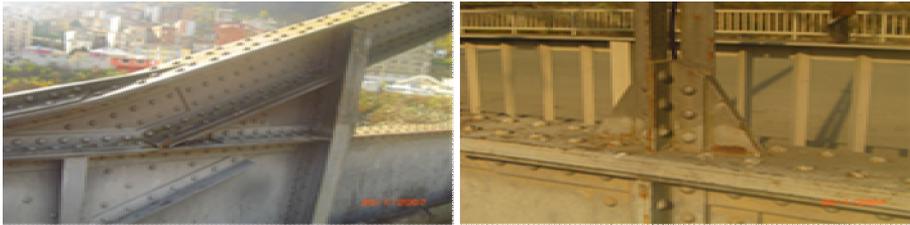
Fig. 4. The capped rivet connections.
