TYPICAL DISEASES OF THE STONE ARCH BRIDGES IN THE MOUNTAINOUS AREAS OF CHINA AND THEIR REMEDIES

Guowen Yao, Pengxi Zou, Gang Liao

School of Civil Engineering, Chongqing Jiaotong University, Chongqing, CHINA.

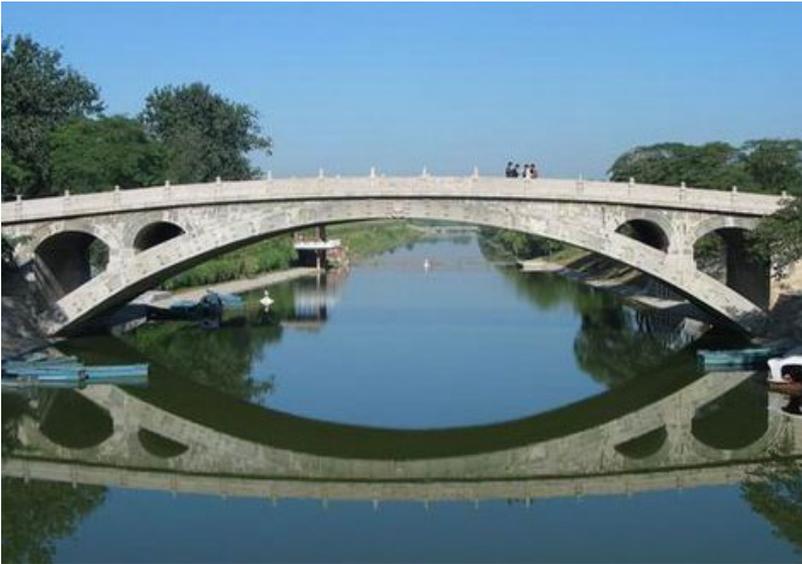
The stone arch bridges are one of the basic bridge which appeared early in China, when it appeared, it had been a tremendous development. A large number of the arch stone bridge stand on the river or between the mountains, the Zhaozhou bridge shown in Fig. 1 is one of the most representative, which is more than 1400 years old. With a lot of construction in the Stone Arch bridge, some of them have been damaged in varying degrees. This paper summarizes the typical disease of stone arch bridge, and analysed the reasons by the actual investigation and literature collection.

Fig. 1. The ZhaoZhou Bridge.

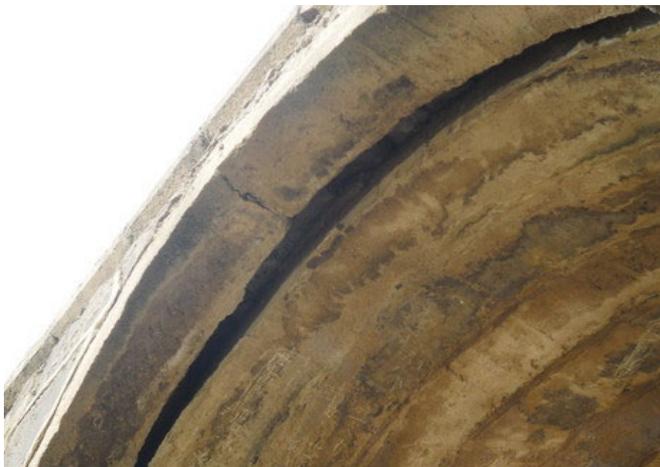
Fig. 2. Longitudinal cracks in the main arch ring.

The main arch ring of longitudinal cracks shown in Fig. 2 is one of the most common cracks in the stone arch Bridges. The cause of the disease, detected by detailed investigations and analysis, are summarized. These reasons include the poor quality of construction, the imperfection of the arch ring, the asymmetry of the padding on the arch ring, earth pressure and eccentric live loads.

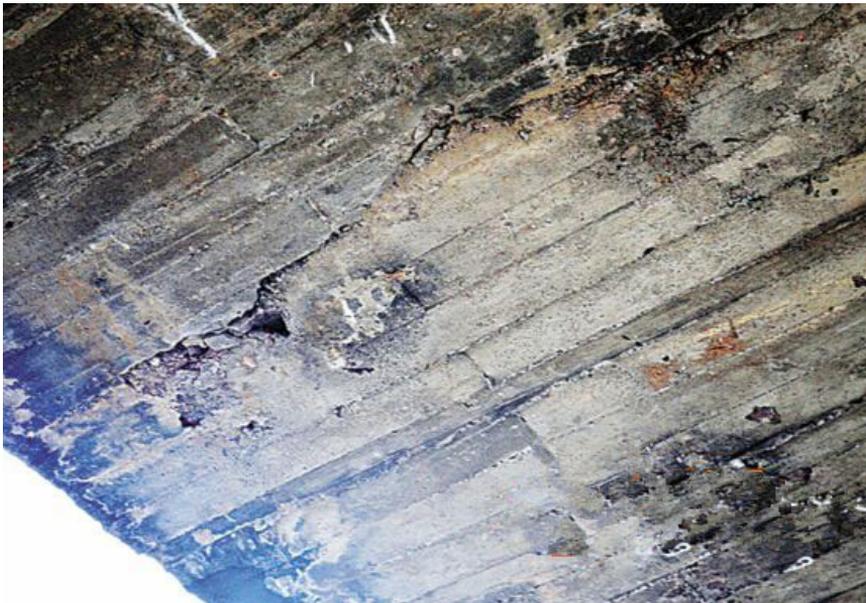
Fig.3. The transverse cracks in the spandrel arch ring.

Transverse cracks in the spandrel arch ring shown in Fig.3 is one of the most common cracks in the stone arch bridges. The main causes of cracks include:

- 1) The inadequate aggregated rock strength lead to partial deteriorated strength in the arch ring. The section of the arch bridge can't provide the sufficient resistance in the load transfer, which finally leads to the transverse cracks in the spandrel arch ring.

- 2) The displacement of the pier and the basic results in transverse cracks. The most widely known Stone Arch Bridges are the redundant structure. If the pier and the basic generate displacement, the internal force redistribution will emerge in the bridge, and then ,some section in the spandrel arch ring can't bear the action from the superstructure, which results in the transverse cracks.

- 3) Asymmetrical loading on the arch ring. The cracking which is caused by this kind of situation occurs mainly on the ramp bridge. Some bridge's slope is sharply, however, the arch ring is horizontal in the design, as a result, spandrel construction is not symmetrical. The arch ring get the stress from the spandrel construction, and then the transverse cracks are appearing in the spandrel arch ring.

- 4) The longitudinal slip or rotation of pier and abutment is also one of the reasons for resulting in transverse cracks in the spandrel arch ring.
- 5) Poor construction quality have an effect on it, such as imperfect mortar between the stones and non-standard masonry techniques.

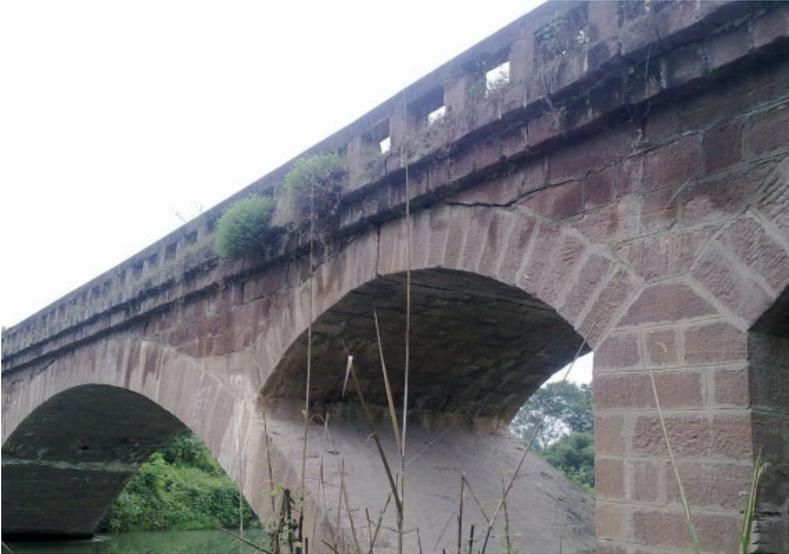
Fig. 4. The side wall leaning outwards.

This disease shown in Fig. 4 is often caused by serious side wall cracking or cracks under excessive, and the main factors causing these cracks include: The arch filler is insufficient or not dense, the load from the deck is too large, the strength of masonry is too low in the side wall, construction quality is poor and so on.

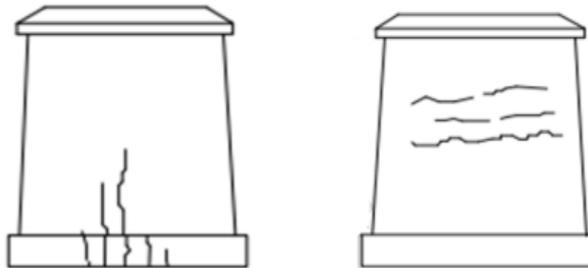
Fig. 5. The abutment cracking.

The side wall or front wall often appear the transverse cracks and the longitudinal cracks shown in Fig. 5, cracks expand along the contact surface of mortar or stone. Some of the cracks run through the mortar or the stone, and their style of width can be the wide intermediate and the narrow ends. The cracks depth also are different, including deep cracks and surface crack. In short, because of the different diseases, the cracks are not the same.

- 1) The load above the abutment is too large or some vehicles act on the edge of the abutment, and all lead to too much earth pressure on the side wall so the cracks will be on it.
- 2) The filling is not dense in the abutment, and the drainage system is failing.
- 3) The strength of masonry is too low.
- 4) The abutment foundation have the uneven settlement and the slip.
- 5) Design defect and construction poor.

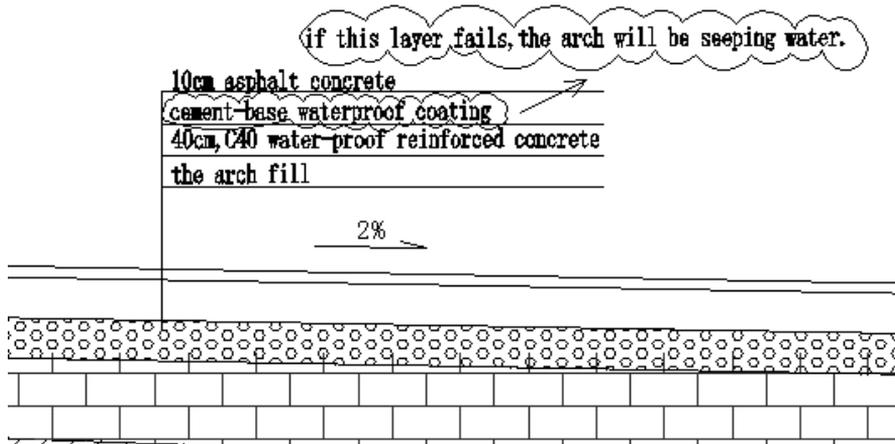
Fig. 6. The schematic diagram.

That the waterproof layer failing is one of the diseases of bridge deck pavement, this disease shown in Fig. 6 can result in the Water-Seepage, and influence the durability of bridge structures. there are some reasons about this diseases. The waterproof layer fracture in the construction loads. Due to the uneven deck pavement or the uneven waterproof layer, the thinner waterproof layer have the leakage on the loads. The waterproof layer maybe damage in the secondary circuit construction. The construction quality is too poor for the waterproof layer.

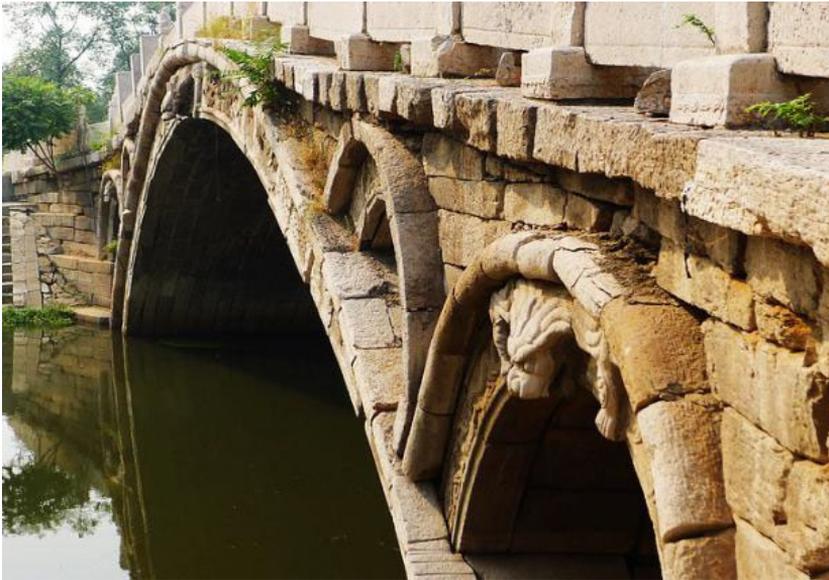
Fig. 7. The stones seriously weathered and eroded.

Stone is exposed to the air, or soak in the sewage for a long time, which results in reducing their physical properties, and then, the ultimate bearing capacity is reduced in the Stone Arch Bridges. This disease is shown in Fig. 7.

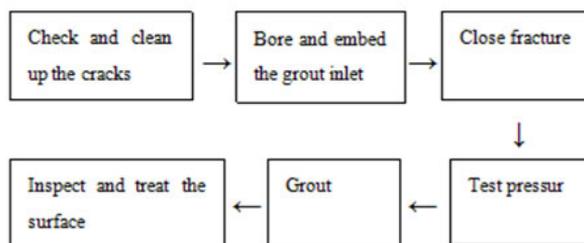
Fig. 8. The process of pressure grouting.

Crack grouting is a method that grouter inject the Epoxy Resin Binder which is the proportion of configuration into the construction cracks in the certain pressure. It plays a certain function that close fracture and enhance the strength of construction. The main construction technology process about the pressure grouting are summarized. The process shown in Fig. 8 include: check and clean up the cracks→bore and embed the grout inlet→close fracture→test pressure→grout→inspect and treat the surface. Moreover, What calls for special attention is that the safety problem in the process of construction. The announcements include note the ventilation to prevent technical personnel poisoning at the construction site, grouting material should be sealed storage, construction personnel should wear mouth shad, rubber gloves and safety goggles, when physical contact to the Epoxy Resin Binder, don't use the acetone cleaning, the correct way is erasing with sawdust or household cleanser firstly, and washing with the hot soapy water, the machinery of the construction should use the acetone, toluene or hot water cleaning. no open flame at the construction site, pay attention to recycle the instrument and the residual liquid to prevent pollution of the environment.

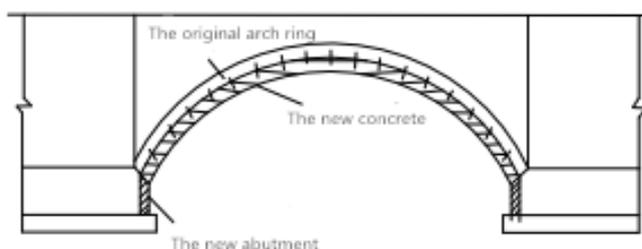
Fig. 9. The bridge is under construction.

In order to the load-bearing structure of stone arch bridge strengthened, we can use reinforced concrete to increase arch cross-section. this method is mainly used in case of the bearing capacity drops or some elements fails caused by the deformation of Arch Axis, cracks of the main arch and other diseases. The reinforcement technology shown in Fig.9 through the addition of the original owners arch soffit and sides of or vault a layer of reinforced concrete reinforcement layer so as to form a composite main arch, coordinated by composite main arch deformation, the main arch of old and new common force, to enhance the main arch, enhance the role of carrying capacity.

Augmented section of stone arch bridge strengthened is one of a more common approach, it has the advantages of uninterrupted traffic, this method is applied in practice, should pay attention to the following requirements: bridge clearance should be relatively large, after increasing the cross-section shall also meet the requirements for clearance under the bridge, but the bridge cannot be reduced spillway section; requirements bridge foundation is good enough to withstand the additional stress produced by live new sectional. piers size to meet the requirements of the new arch can withstand additional thrust.

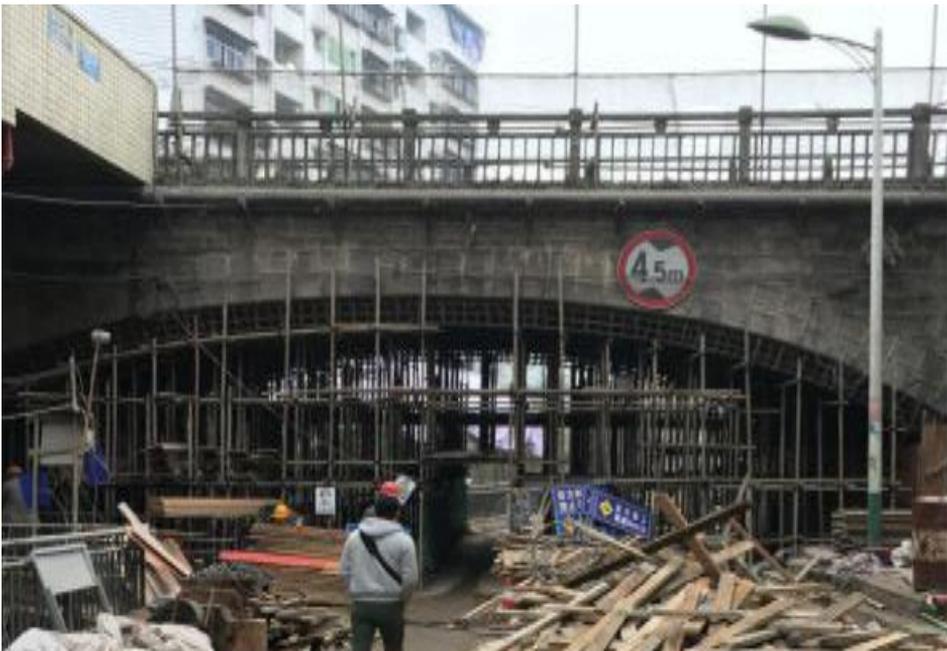
Fig. 10. Hooped with reinforcement concrete.

This method shown in Fig.10 include adding the hoop of the reinforced concrete floors to develop the composite arch ring. Use this theory that the composite arch ring can be consistent deformation and bear load together to increase the strength and stiffness of the main arch ring, and then, increase the bearing capacity.

- 1) Make full use of theory that the structural strength have a significantly increase from three-directional pressure.
- 2) Don't need to terminate the traffic at the construction site,
- 3) The hoop of the reinforced concrete floors can cast in place to achieve high strength of concrete, overcome the disadvantage of sprayed concrete, at the same time, increase the cross section and stiffness of the arch ring, and improve the ultimate bearing capacity and aseismic capacity.
- 4) That the new pouring concrete layer wrapped in old main arch ring increase the durability of the structure, enhance the capacity of water erosion prevention in the main arch ring and enhance the capacity of resistance to weather.

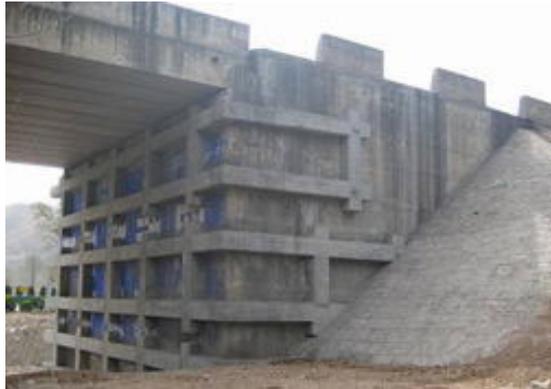
Fig. 11. Hooped by a frame beam with bolt grouting.

Due to the depth of bridge pier embedment is not enough or construct poorly, the abutment cracks, and even the penetrating crack appears. At the same time, the front wall and side wall of abutments were hooped by a frame beam with bolt grouting, the side wall of abutment was fixed by transverse steel bars. In this way, we can improve the integrity of the structure and the bearing capacity. This method is shown in Fig.11.

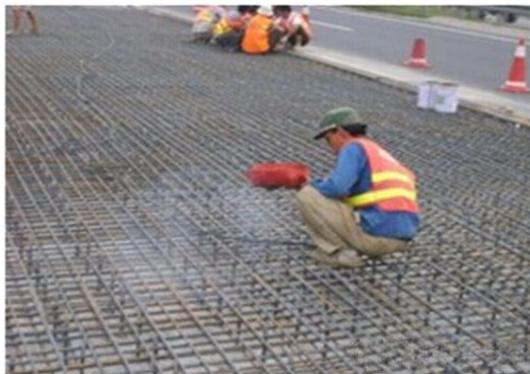
Fig.12. Replace the bridge deck pavement.

Due to the vehicle overload and construction poor about the side of the waterproof layer, the arch ring have the water seepage problem, and the ridge deck pavement is failing. For the control of the disease, we can take the following actions :

- 1) The bridge deck pavement was replaced with a new one including an effective waterproof layer. The construction of the replacement should be carried out strictly in line with the construction technique to ensure the construction quality. This method is shown in Fig.12.
- 2) Using the waterproof concrete, it has good waterproof effect and durability. We should lay a waterproof screeding layer which is 5~10 cm to adjust the transverse slope of the bridge deck and possess the effect of waterproof. If we lay the asphalt on the screeding layer, the effect of waterproof will be better.
- 3) Deformation cracks and expansion joints should be focus on the side of the waterproof.
