HISTORY OF A FAULTY RETROFITTING: THE S. SEBASTIAN BRIDGE IN LOANO (ITALY)

F. Bonfiglietti¹, A. Brencich²

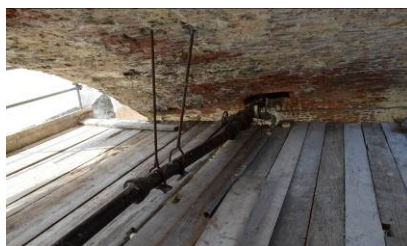
Fig. 2. Water pipe below the bridge – 2nd half of 19th century.

In the 2nd half of the 19th century a water pipe, Fig. 1, was placed below the bridge through a couple of holes in the arch barrel, Fig. 2. Around 1930, a gas pipe was placed below the pavement on the southern side; close to 1960 a concrete pavement (10cm thick) was placed over the old cobblestone, Fig. 3.

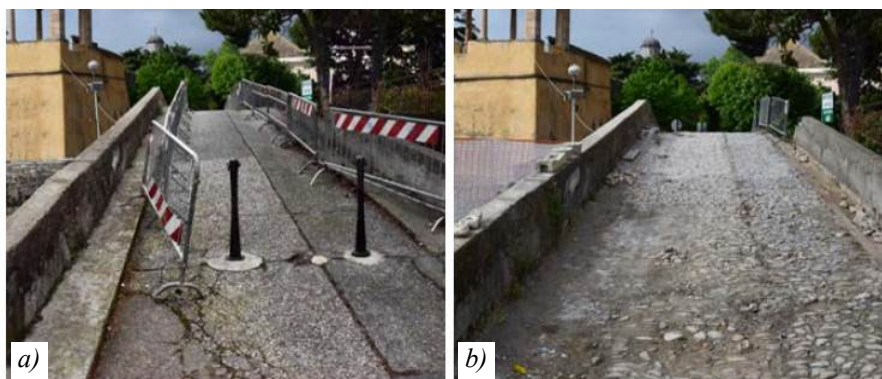
Fig. 3. a) Concrete pavement (1960 approx.). b) Original cobblestone on the right (after removal of the concrete layer). The southern side is on the left. On the right the „hole” in the spandrel due to the collapse of the aedicule.

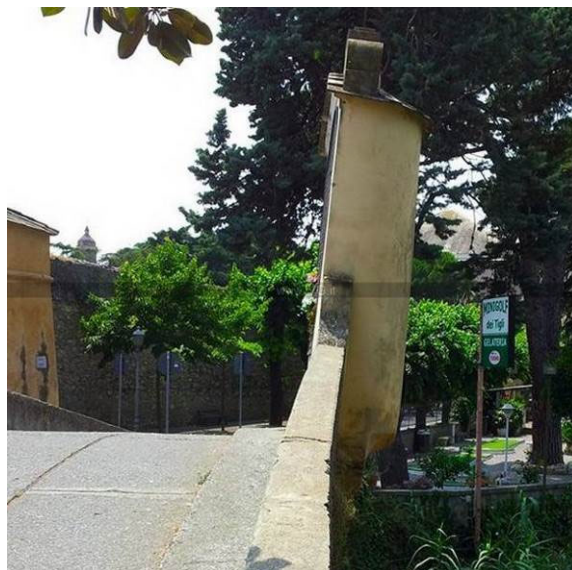
Fig. 4. Few hours before the collapse.

The 4th of July 2013 at 7PM, apparently with no reason (no wind, no impact, no load), the aedicule collapsed along with part of the armilla. Fig. 4 shows its inclination few hours before the collapse. Fig. 5 shows the collapsed armilla and the texture of the arch barrel.

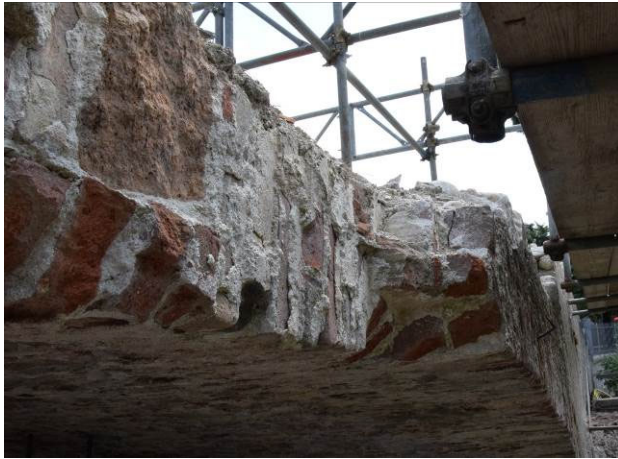
Fig. 5. Collapsed armilla on the northern side.

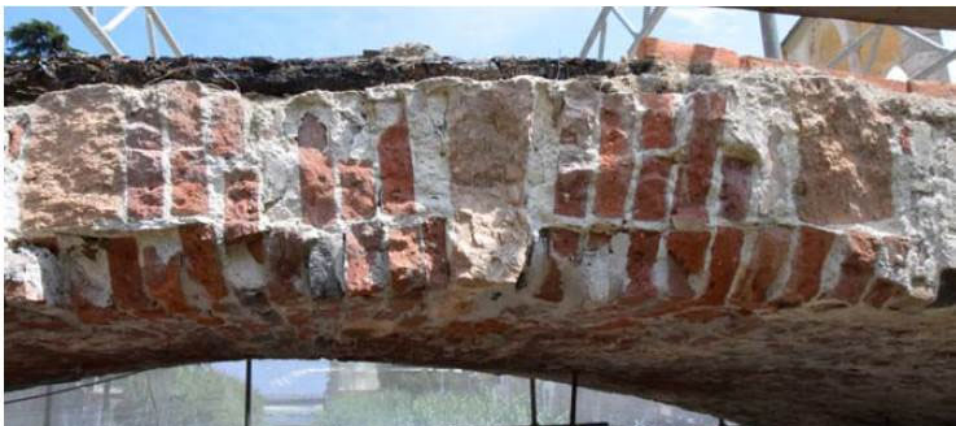
As figure 1 shows, the aedicule was supported by 3 cantilevers fixed in the barrel brickwork. Fig. 6 shows the remains of the cantilevers after collapse outlining that the stones cracked but did not slide outside the arch, which means that no collapse of the cantilever restraints took place.

Fig. 6. Frontal view of the cracked surface.

- 2) the cantilevers were simply “substituted”: once removed the survived parts, figure 6, new cantilevers (same geometry of the ancient ones) were replaced in the arch barrel using expansive mortars to fix them in the arch. The armilla and the aedicule were later rebuilt using standard techniques. Such a procedure is uncertain since the removal of the survived parts of the cantilevers removes also the compressive stresses that guarantee the restraint to the cantilevers, figure 10.b. Besides, using the same material, the fatigue issue is not solved at all.

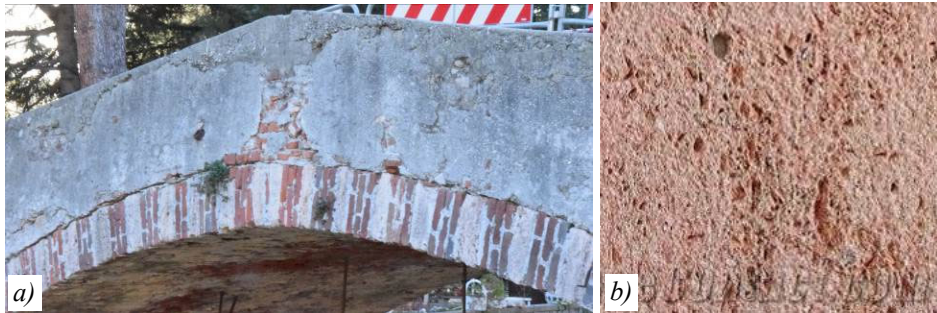
Fig. 7. a) Spandrel on the south side: bad conditions and sliding (?) at the arch-spandrel interface; b) texture of the Finale Stone (rose type).

The spandrels were generally in bad conditions and sliding on the arch-spandrel interface appeared, Fig. 7a.

The compressive strength of solid clay brickwork was assumed not lower than 5 MPa. The Finale stone of the cantilevers is a local stone, highly inhomogeneous, figure 7b, exhibiting low and highly variable mechanical properties: $f_t = 3-8$ MPa and $f_c = 23-64$ MPa.
