RETROFITTING OF A MASONRY ARCH VIADUCT AND CULVERT

J. Hołowaty¹, D. Jurkowski², G. Zimny²

SUMMARY

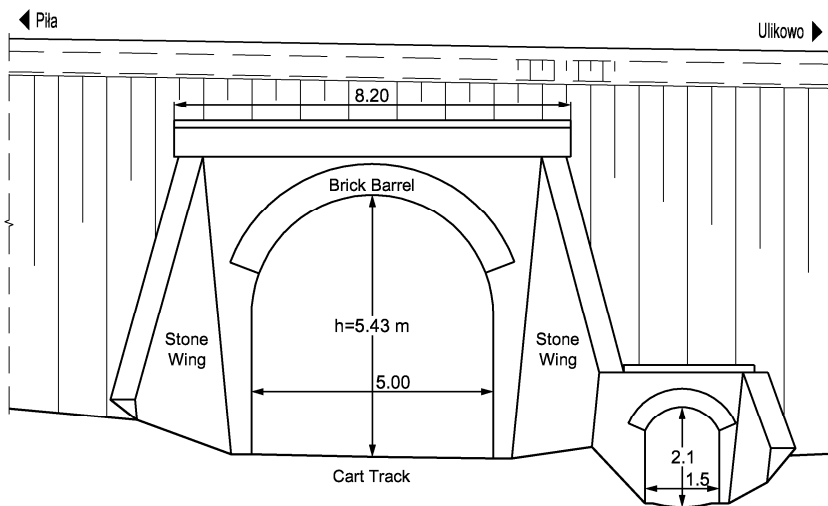
Fig. 1. North elevation of the masonry arch structure.

The bridge structure was constructed in 1895 as one of the engineering structures for the current Piła and Ulikowo Railway Line. The masonry structure was constructed as two-span with brick barrel arches for the viaduct and the culvert. The supports and wings were constructed from stone blocks (Fig. 1). The culvert was constructed to take the water flow from the hillside where the railway line embankment is situated.

The brick barrel arches are supported by wedge-shaped stones on stone walls at the springing. The support and wing walls are stone masonry from rectangular stone blocks and mortar joints. The sections of the structure are presented in Figs. 1 to 3, with the characteristic patterns of cracks and crevices generally visible. General views of the viaduct and the culvert (conduit) before retrofitting are shown in Figs. 4 and 5, with excessive vegetation flourishing near the structure.

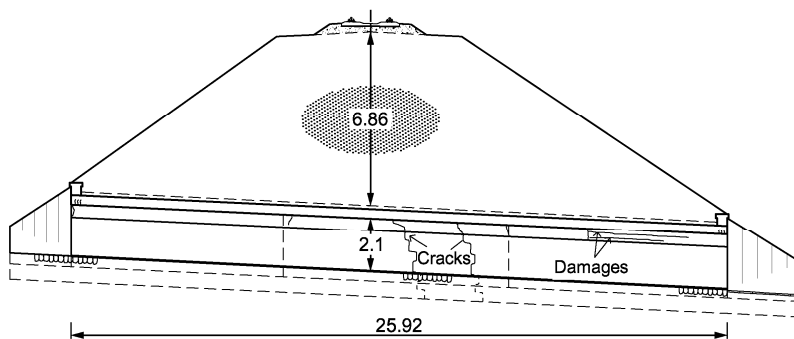
Fig. 3. Culvert longitudinal section.

The width of the viaduct is 11.0 m with the length 5.30 m (Fig. 2). The clear span of the viaduct is 5.0 m. The road under the viaduct allows access to a forest nature reserve and an old burial site. The total length of the culvert, located alongside the viaduct support, is 26.0 m. The culvert clearances are 1.5 m (horizontal) and 2.1 m (vertical), respectively. The bottom of the culvert is stone faced (Fig. 1 & 3). The culvert is bent in plan.

Damage to the culvert structure were more severe, with wider crevices in the stone wall at the settlement, and crevices and cracks in the culvert barrel arch. At the location of water shedding from the viaduct side, there was excessive leakage and dampening of the masonry walls and the barrel arch, which had resulted in the destruction of the mortar joint and brick material. The stone wall was stained by calcareous leakage. Damage to the brick parts had also appeared on the head parts of the culvert made by the water shedding on the embankment slopes. Excessive damage occurred on the end section of the culvert conduit of 5.5 m in length where water was shedding extensively from the viaduct. Crevices in the side stone walls of the culvert also in evidence through the mortar joints. The stone surfacing of the culvert bottom was found to be in very good condition.

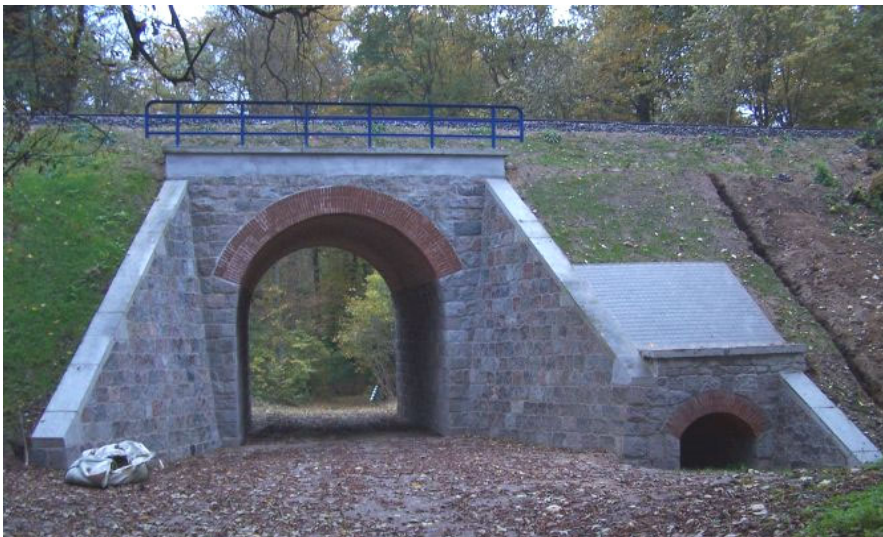
Fig. 6. North elevation of the masonry arch structure after retrofitting

General views of the viaduct and the culvert during the finishing works are shown in Fig. 6. Figures 7 and 8 present the longitudinal cracks in the viaduct brick barrel before and after repair. The brick masonry is very sound despite the cracking.

The retrofit of the masonry arch viaduct and culvert assumed the protection of the barrel arches against water with the construction of a new drainage system, injections into the cracks and crevices, strengthening of the connection between the barrel arches and the spandrels at the crowns, local strengthening of the stone walls and foundations, replacement of the deteriorated bricks, brick masonry repair, repair of the mortar joints with repointing, sand blasting of the structure surfaces and the application of penetrant and protective coatings. All the members and embankment slopes were cleared of vegetation. Railings on the viaduct were added and the stairs on the slope were repaired.

The simplicity of the arch structure along with its structural and aesthetic values allowed a typical range of repair and retrofitting works to be drafted which do not influence the appearance and the behaviour of the structure to a large extent. The repair works and local strengthening have not altered the elevations and structural behaviour. The culvert structure was preserved after the repair and replacement of the deteriorated masonry and strengthening despite an accepted proposal to line it with a corrugated steel pipe. The head walls of the culvert were rebuilt using the same stones and plates. They were also protected from water shedding from the slopes, and precast gutters were installed.
